TEST REPORT

No. : SM110100695

Sample Name : CASTOR WHEEL
Sample Number : SM110100695
Product Specification : 6"
Test Required : Proof load test, Loading test
Date of Receipt : Jan. 17,2011
Test Period : Jan. 17,2011 to Jan. 25,2011

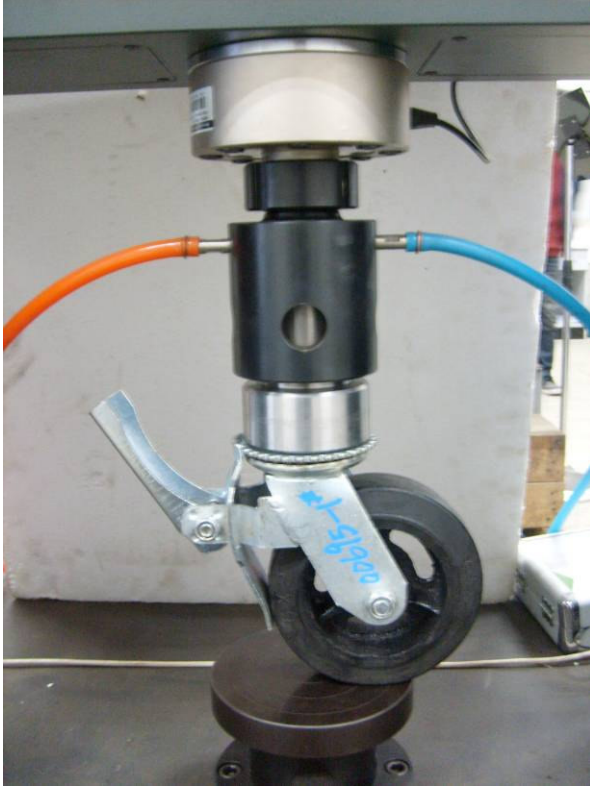
Fig. 1 Before test(Sample 1#)

Test method: Per client's requirement, assemble the sample(s) into testing machine (Fig.1 to Fig.4), apply 500kgf (safety load) to the sample(s), and then release force. After test, observe deformation and damage on the sample(s).

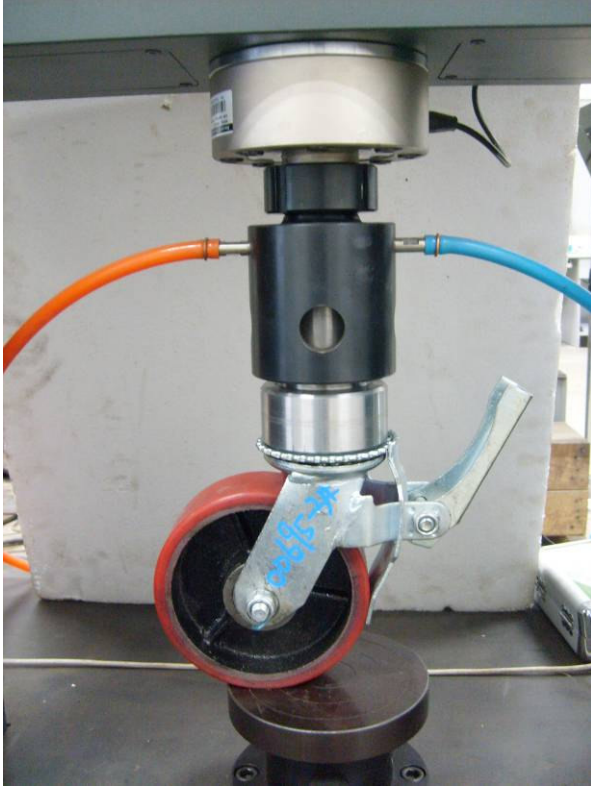
Fig. 3 Before test(Sample 3#)

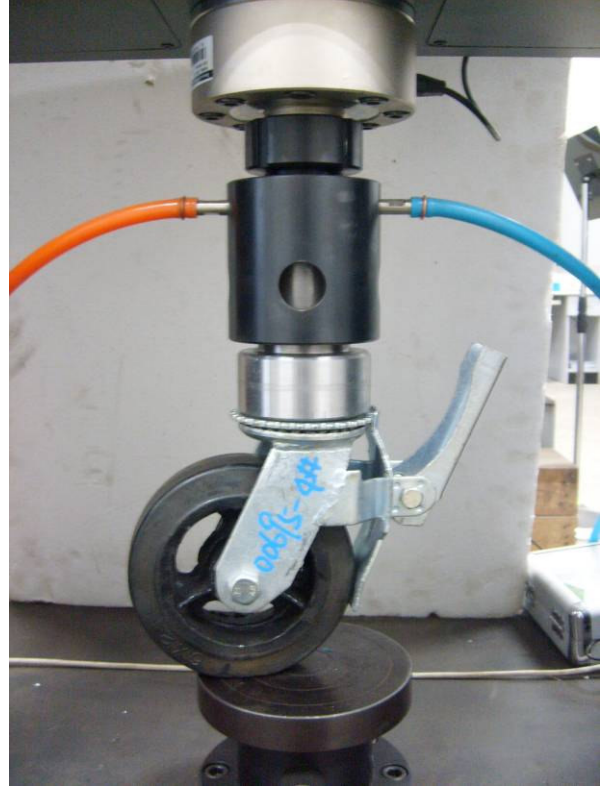
Fig. 4 Before test(Sample 4#)

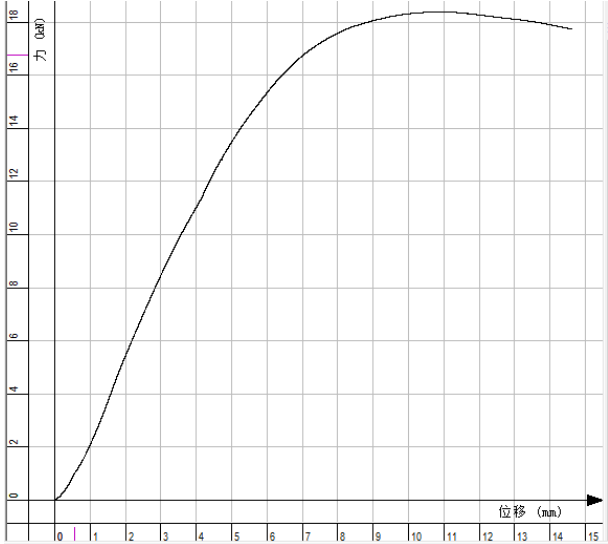
Force-displacement curve for loading test
(Sample 2#)

Sample	Breaking force (kgf)	Breaking position
1#	1631	See Fig.5 and no damage on rubber
2#	1873	See Fig.6 and no damage on rubber
3#	1548	See Fig.7 and no damage on rubber
4#	1778	See Fig.8 and no damage on rubber

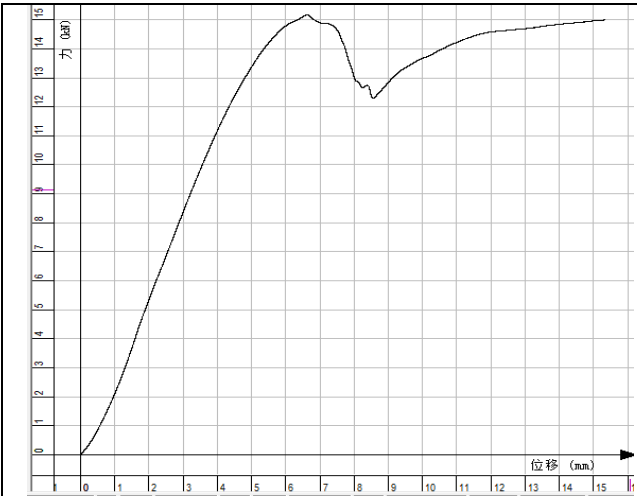
Force-displacement curve for loading test
(Sample 3#)

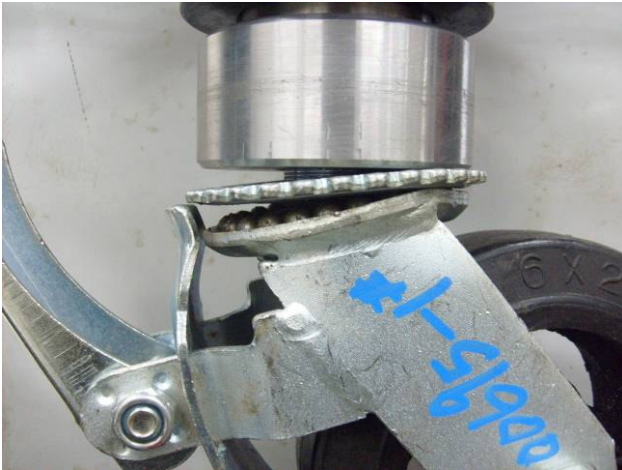
Fig. 5 After loading test (Sample 1#)

Test method: Per client's requirement, assemble the samples(s) into testing machine (Fig.5 to Fig.8), apply load to the sample(s) until the sample(s) broken, record the breaking force and the breaking position.

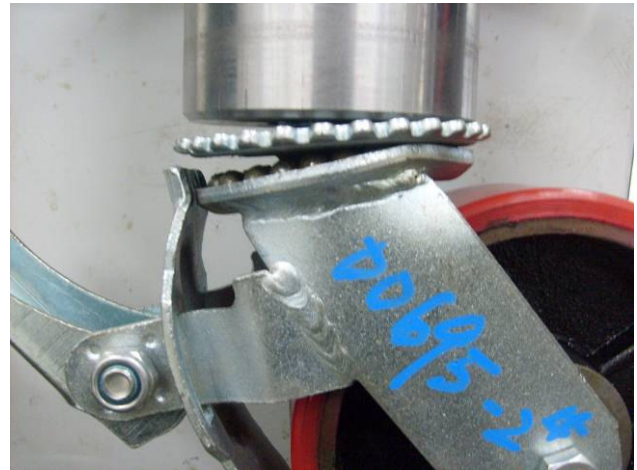
Fig. 6 After loading test (Sample 2#)

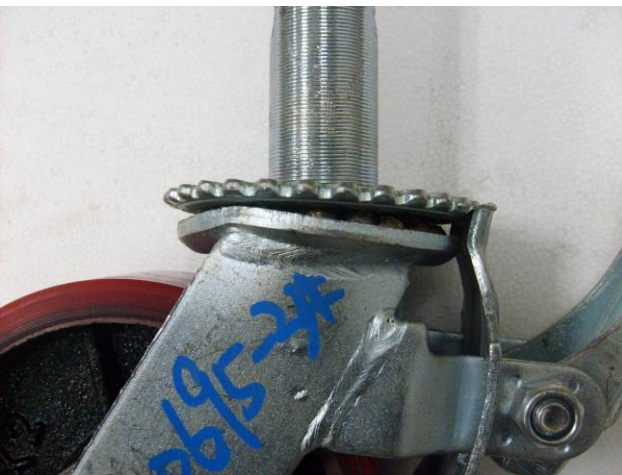
Fig. 7 After loading test (Sample 3#)

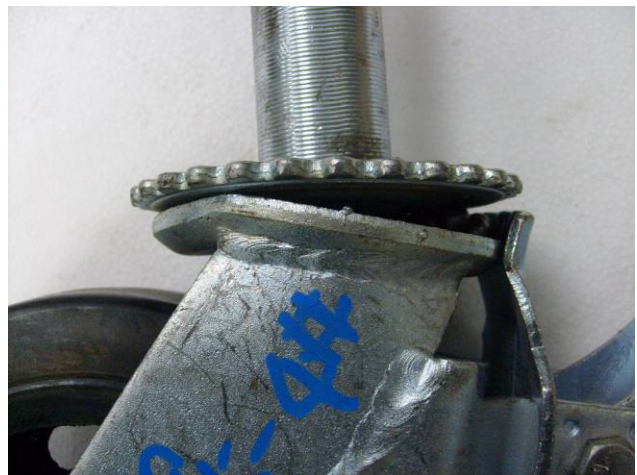
Fig. 8 After loading test (Sample 4#)
